**PERIODIC DAM SAFETY INSPECTION REPORT**

**HARTLAND HOMES NORTH DAM**

**IDENTIFICATION NUMBER NE02516**

**INSPECTED: 04/21/2016**

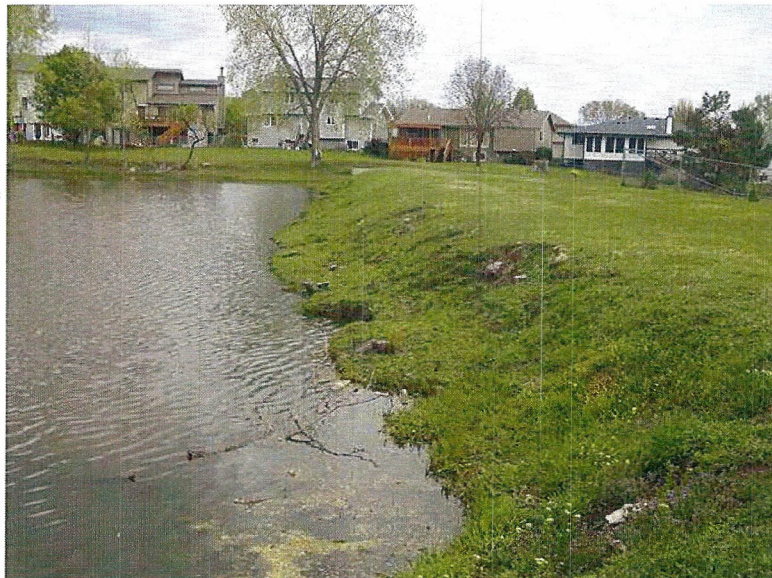
b. Trees?		X		The trees that used to grow on the dam have been cut down. However, several of the stumps remain in place.
	c. Rodent holes?	X			There were a few burrows into the dam at the reservoir level. The burrows did not appear to be large enough to be beavers. They may be muskrat burrows.

The upstream slope. Note the stumps still in place from trees cut down in the past. Also note the burrow into the dam along the shoreline.

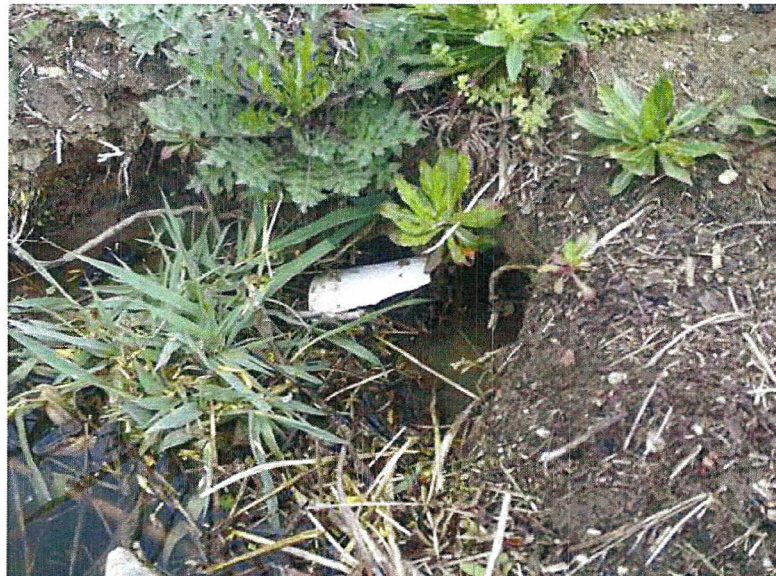
**RODENT BURROWS.** A few rodent burrows were found along the shoreline of the upstream slope. The burrows appeared to be too small to be from beavers. The burrows could be caused by muskrats. If so, they could be entrances to dens inside the dam embankment.

On the dam embankment, burrows can provide paths for reservoir water to flow through the dam embankment and possibly appear as seepage on the downstream slope.

One of the burrows into the dam along the shoreline of the upstream slope.

All rodent activity on the dam embankment should be eradicated. Then, the burrows should be backfilled.

After the rodents are removed, the recommended method of backfilling the burrows is mud-packing. This simple, inexpensive method can be accomplished by following these steps:

1. A mud-pack mixture is made by adding water to a 90 percent earth and 10 percent cement mixture until a slurry of thin cement consistency is attained.
2. The mud-pack mixture is poured into the burrow until the burrow is filled to within one foot of the burrow entrance with the earth-water mixture.
3. Dry, well-compacted earth is tamped into the top one foot of the burrow.
4. The affected area can then be reseeded, if necessary.

If there are muskrat dens within the dam embankment, once the muskrats have been eradicated, the affected portion of the embankment will need to be excavated, reconstructed, compacted properly, and reseeded.

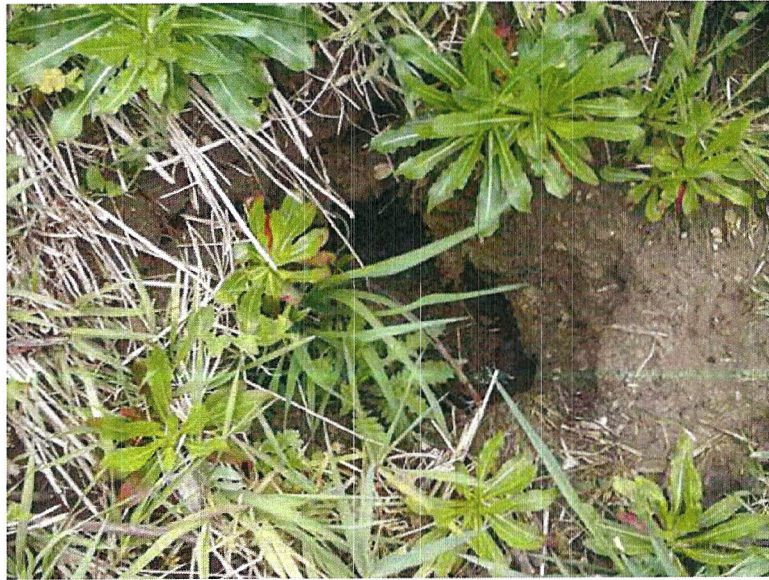
Another of the burrows into the dam along the shoreline of the upstream slope.

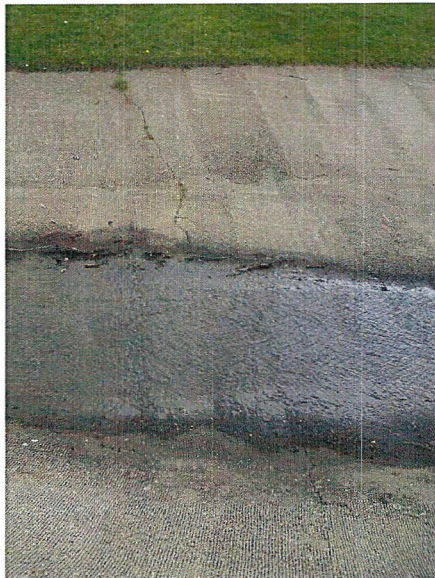
1. A transverse crack across the spillway about 20 feet downstream of the spillway inlet.
2. A longitudinal crack along the right side slope of the spillway in the middle portion of the spillway.

An unsealed transverse crack running across the spillway about 20 feet downstream of the spillway inlet.

The cracks should be sealed with a polyurethane caulk to ensure that:

1. Freeze-thaw damage does not occur in the affected area(s).
2. The steel reinforcement within the concrete is not exposed to moisture. If the steel reinforcement is exposed to moisture, it will corrode and swell, which will break up the surrounding concrete.

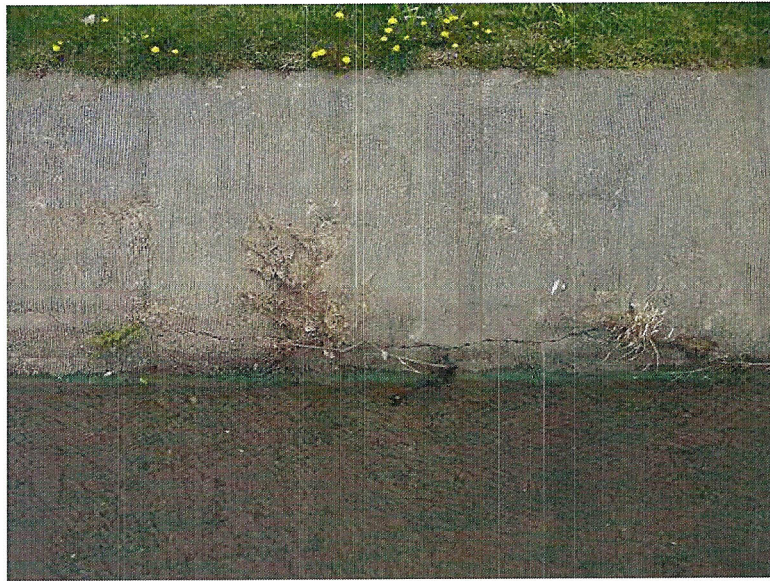
An unsealed longitudinal crack running along the right side slope of the spillway, in the middle portion of the spillway.
